THE CHARACTERIZATION AND ANALYSIS OF ORNAMENTAL  
CAST STONE AND STUCCO FROM THE PALACIO ERRÁZURIZ,  
BUENOS AIRES, ARGENTINA

James Valente Banta

A THESIS

1995

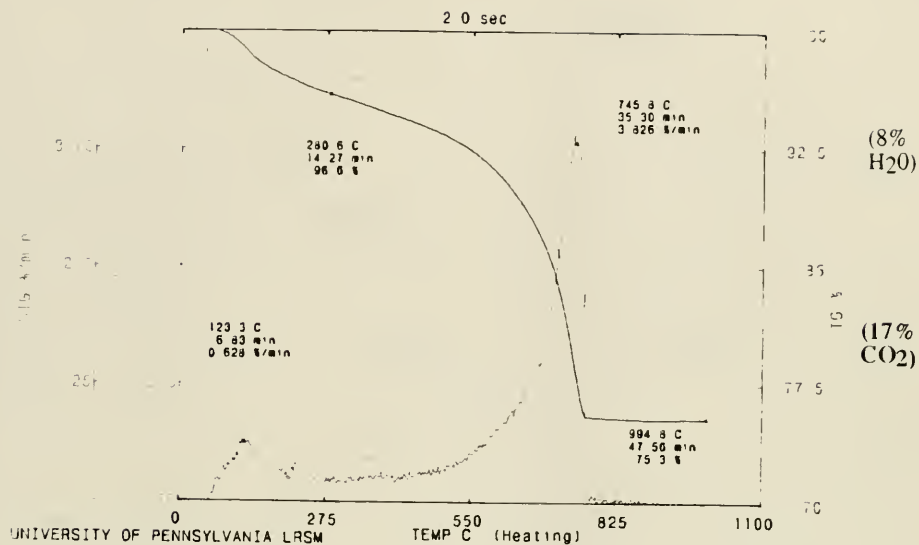
## Sample ER 1

17% CO<sub>2</sub> + 10 mg starting weight of sample ER 1 = 1.7 mg CO<sub>2</sub>

$$\frac{1.7 \text{ mg CO}_2 \times 100 \text{ g CaCO}_3}{44 \text{ g CO}_2} = 3.86 \text{ mg}$$

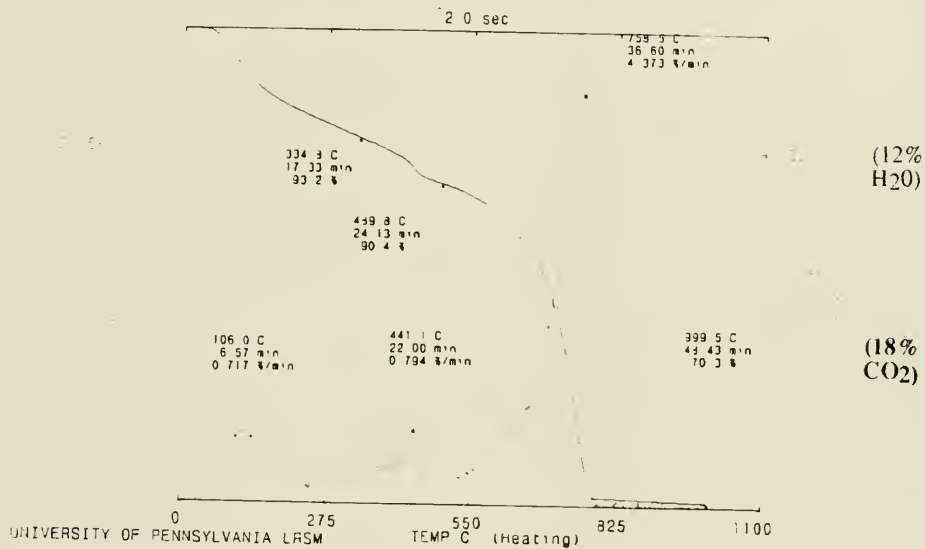
## Sample ER 2

18% CO<sub>2</sub> ÷ 9.8 mg starting weight of sample ER 2 = 1.8 mg CO<sub>2</sub>

$$\frac{1.8 \text{ mg CO}_2 \times 100 \text{ g CaCO}_3}{44 \text{ g CO}_2} = 4.09 \text{ mg}$$

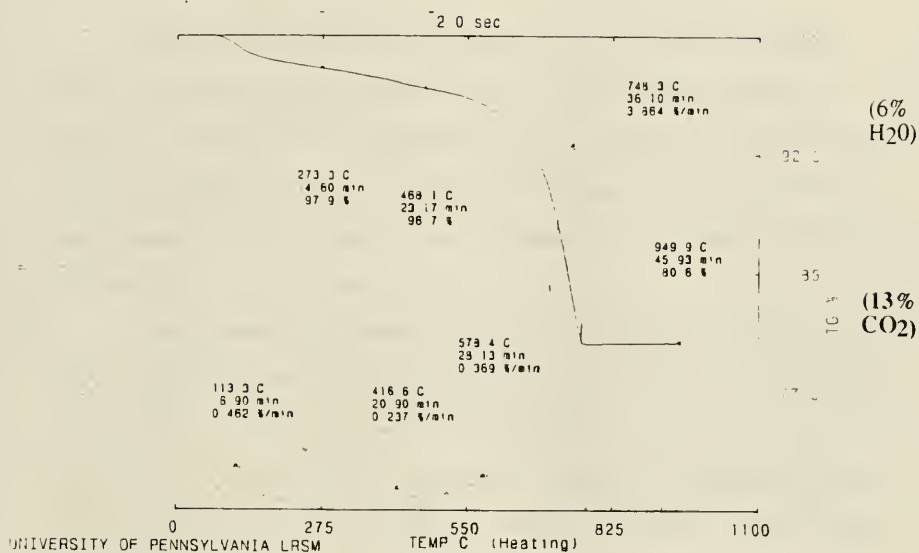
## Sample ER 28

13% CO<sub>2</sub> ÷ 9.5 mg starting weight of sample ER 28 = 1.3 mg CO<sub>2</sub>

$$\frac{1.3 \text{ mg CO}_2 \times 100 \text{ g CaCO}_3}{44 \text{ g CO}_2} = 2.9 \text{ mg}$$

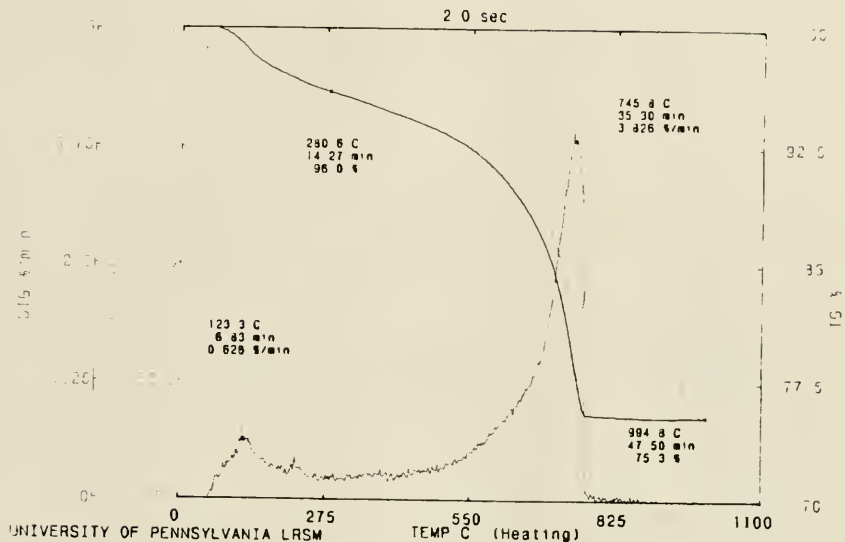
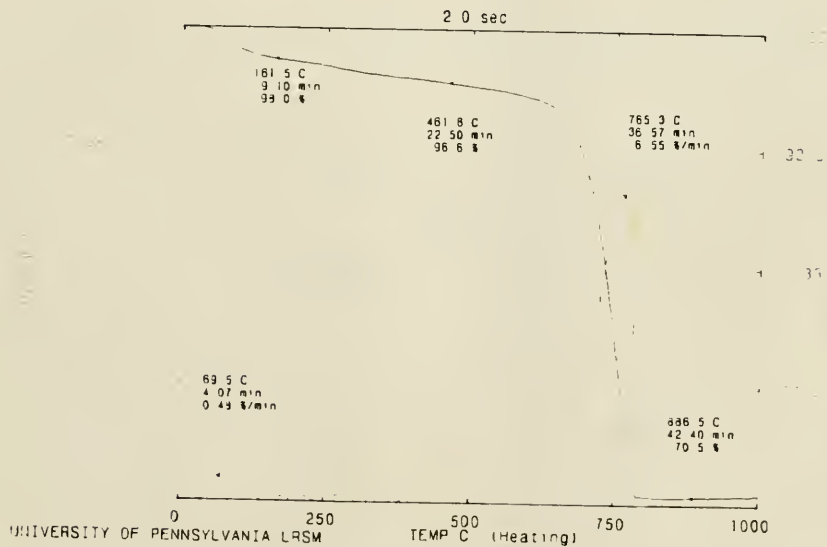
### 13.4.1. Sample ER 1 (top) compared with Standard for White Portland Cement and Lime (bottom)

The presence of a sulfur rich crust on samples ER 1 and ER 2 probably indicates the effects of pollution. (see Illustrations 20, 21, 22, and 23) Sulfur in the atmosphere from industrial production combines with moisture in the atmosphere to react with carbonate-rich masonry and forms sulfate crusts. These sulfur-rich surface layers may also be evidence of a gypsum (calcium sulfate) finish or the presence of bacterial action, but the location from which samples ER 1 and ER 2 were taken suggest another theory.

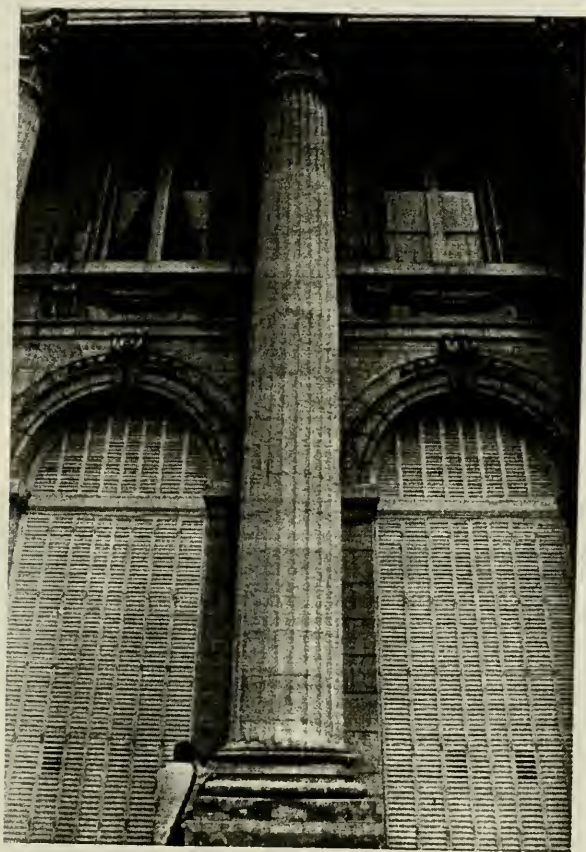
Illustration 9. Palacio Errazuriz, limestone column and base, north facade.

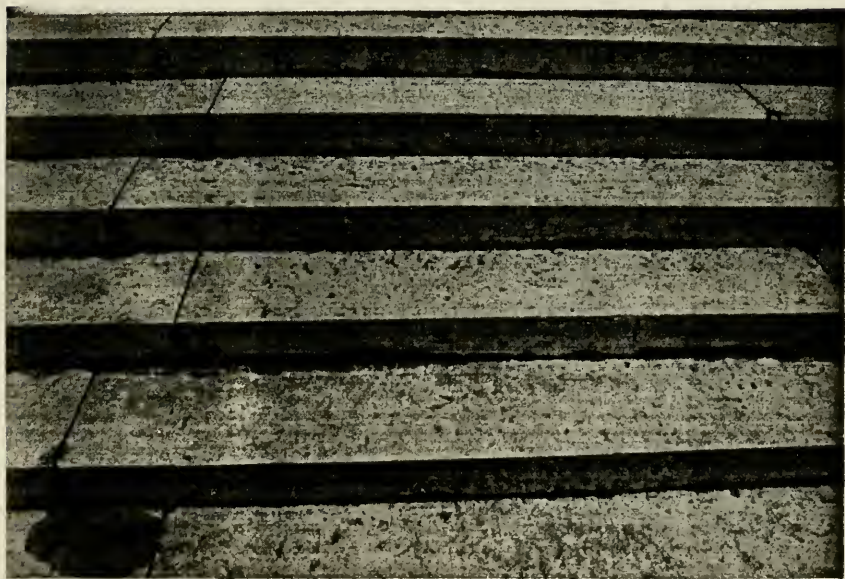
Illustration 11. Palacio Errazuriz, limestone steps, west facade.

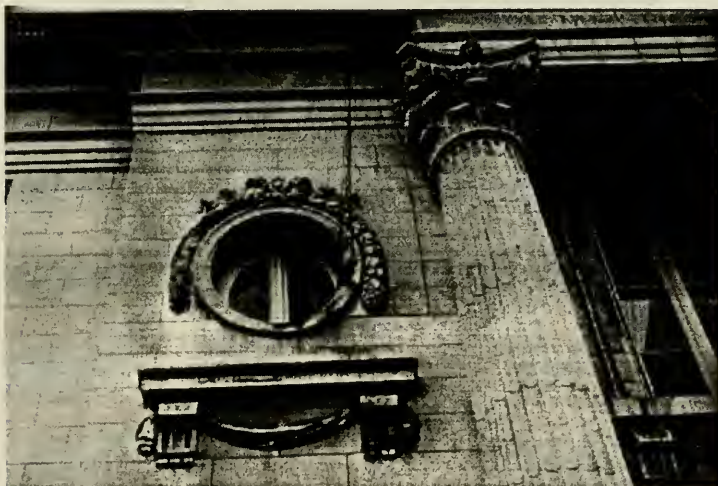
Illustration 13. Palacio Errazuriz, limestone column; cast stone garland, swag, and triglyphs; and scored stucco (north facade). Photo by Frank Matero.
